Procedia Materials Science 11 (2015) 672 – 678

Procedia
Materials Sciencewww.elsevier.com/locate/procedia5th International Biennial Conference on Ultrafine Grained and Nanostructured Materials,
UFGNSM15

Investigation on Corrosion Behaviour of Copper Brazed Joints

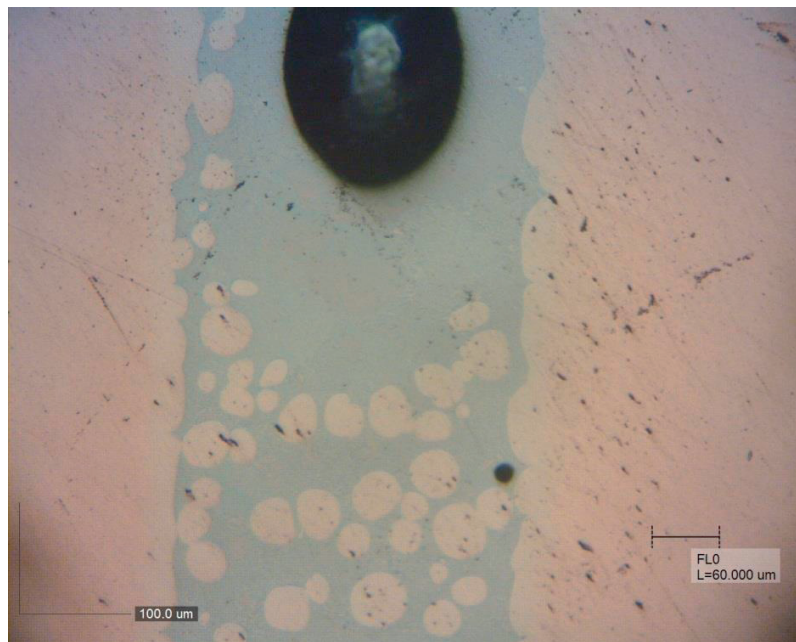
Microstructures of joints brazed with BCuP-2 are given in Fig. 1. As can be seen from the figure, round phosphorus poor dendrites in a matrix of Cu–P are observed. Dendrites have a uniform distribution in the matrix owing to proper brazing conditions, Zhang et al. (2010). Fig. 2. Shows the results of EDS analysis of the brazed samples and table 3 shows the chemical composition determined using EDS analysis of the tested samples after the brazing process.

Fig. 1. Microstructure of the joints using BCuP2 filler metal.

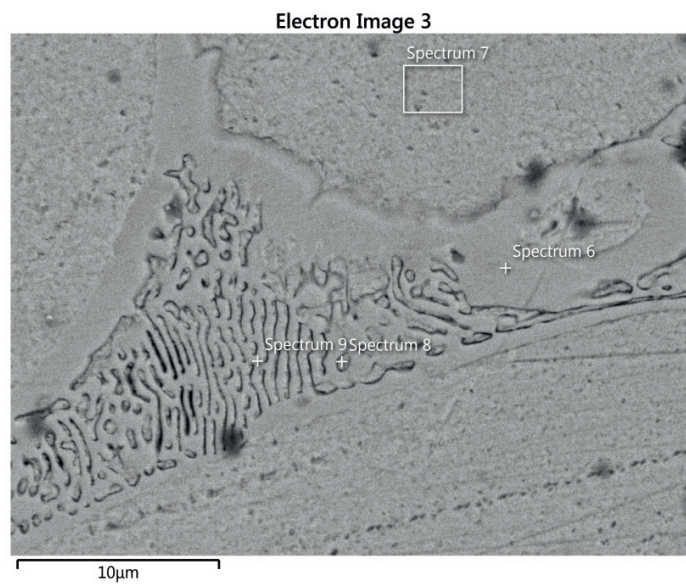
Fig. 2. Detailed microstructure of B-CuP2 filler metal.

Table 3. Chemical composition of the spots given in Fig. 2.

Cu	P	O
Spec6	89.2	10.8	-
Spec7	95.9	2.6	1.5
Spec8	94.3	4.7	1

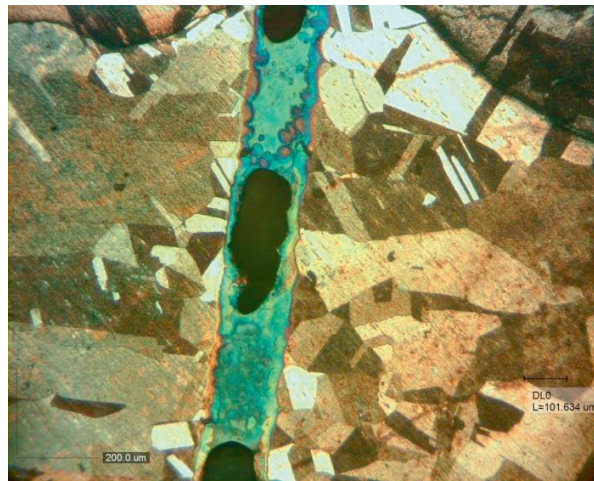
As shown in Fig. 3, BCuP-5 filler metal consists of three different regions. Regions in Fig. 4 are dendrites of copper solid solution (dark-gray 11), Ag–Cu–P eutectic (mottled-gray12) and silver rich dendrites around the eutectic (white10), respectively. Both copper solid solution and silver rich dendrites have irregular shapes, sizes and random orientations in the matrix. Fig. 4 shows the braze layer with higher magnification and the area where EDS analysis was performed. Table 4 shows the chemical composition of the spots in Fig. 4. The silver rich dendrites have more silver content than the nominal chemical composition of the filler metal (i.e. 57.4%Ag in the dendrite).

Fig. 3. Microstructure of the joints brazed with BCuP5 filler metal.

Some discontinuities such as cavity and porosity can be seen within the joint area in Fig. 3. Incomplete brazing is frequently encountered in many brazed configurations. Generally, the reasons for these characteristics are narrow joint clearances, trapped gases, and/or improper filler metal selection.

The reasons for incomplete penetration of the filler into the joint gap using BCuP-5 filler metal are the slow flow property of the filler metal and improper fixing the joint assembly (Fig. 3). Another reason for slow flowing (sluggishness) is the wide melting temperature range of the filler metal (i.e. 650–800 °C).

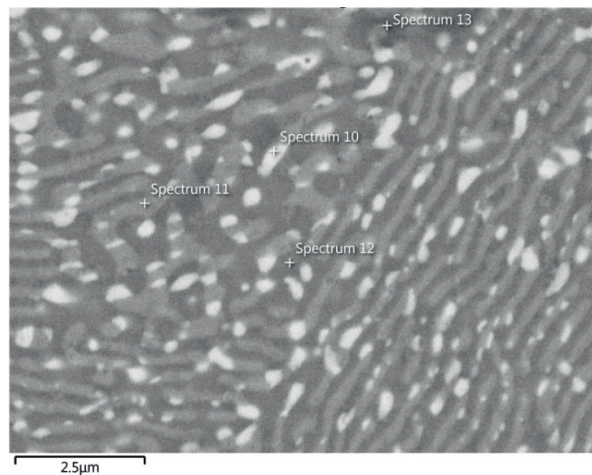
Fig. 4. Detailed microstructure of B-CuP5 filler metal.

Table 4. Chemical composition of the positions.

Ag	Cu	P	O
Spec10	57.4	37.1	4.4	1.1
Spec11	5.6	89.6	4.2	0.6
Spec12	8.4	82.1	9.5	-
Spec13	11.9	77.8	9.2	1.1

Since the melting temperature range of BCuP-2 filler metal is narrow (i.e. 710–740 °C), it has a free flowing behavior and is capable of penetrating narrow joint gaps. Porosity is another frequently observed discontinuity defect in brazed joints. The reasons for porosity are the gases generated from vaporization of the constituents having lower melting temperature, gases produced by flammable materials present in the area to be brazed due to insufficient cleaning of the area or gas produced from some fluxes, Karamiş et al. (2003). Porosity has a high occurrence probability for slow flow filler metals because of the gases trapped in the molten filler metal. Porosity resulting from gases present in molten metal is shown in Fig. 1. Although the filler metal provides a sound bonding because of its free flowing and good wetting properties, porosities cannot be ignored in the samples brazed with BCuP-2 filler metal. Since this filler metal does not contain lower melting temperature alloy, these porosities arise as a result of insufficient cleaning or gases arise from fluxes. In brazing with BCuP-5 filler metal, there are much porosity. The reason for this is the high viscosity of the filler metal and insufficient cleaning of the brazed field also gases arise from fluxes (Fig. 4).
